Norsk Hydro a.s

WELL CRITIQUE - 30/7-5

Årsak til glipp på 20" Casing.

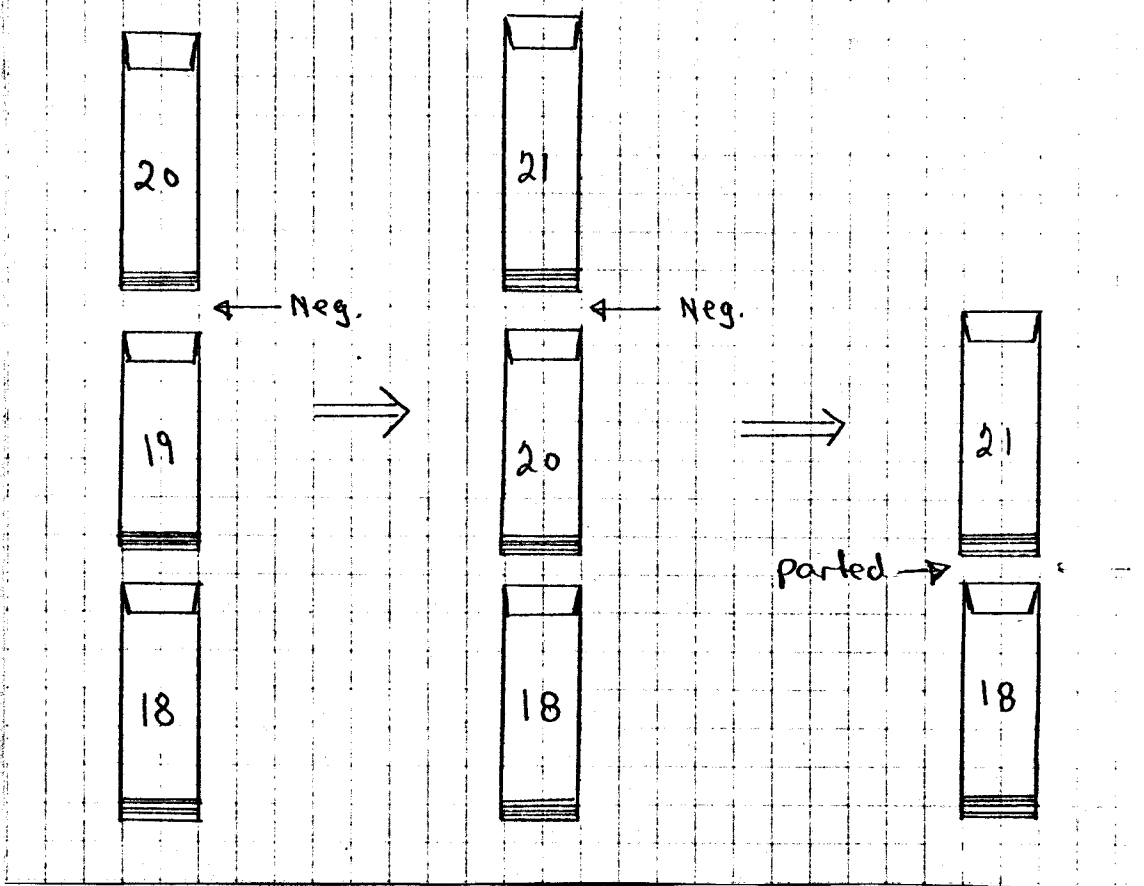
When joint No. 20 should be made up to No. 19 (see sketch), this was not possible due to oval box on No. 19. Joint No. 19 had therefore to be disconnected and joint No. 20 was made up to No. 18. When joint No. 21 should be made up to No. 20 the same happened, and joint No. 20 was disconnected. Joint No. 21 was then made up to No. 18. The casing job was continued problemfree until the casing parted while joint No. 33 was going to be made up to No. 32.

When pulling out of hole it was found that the string had parted between joints No. 18 and 21.

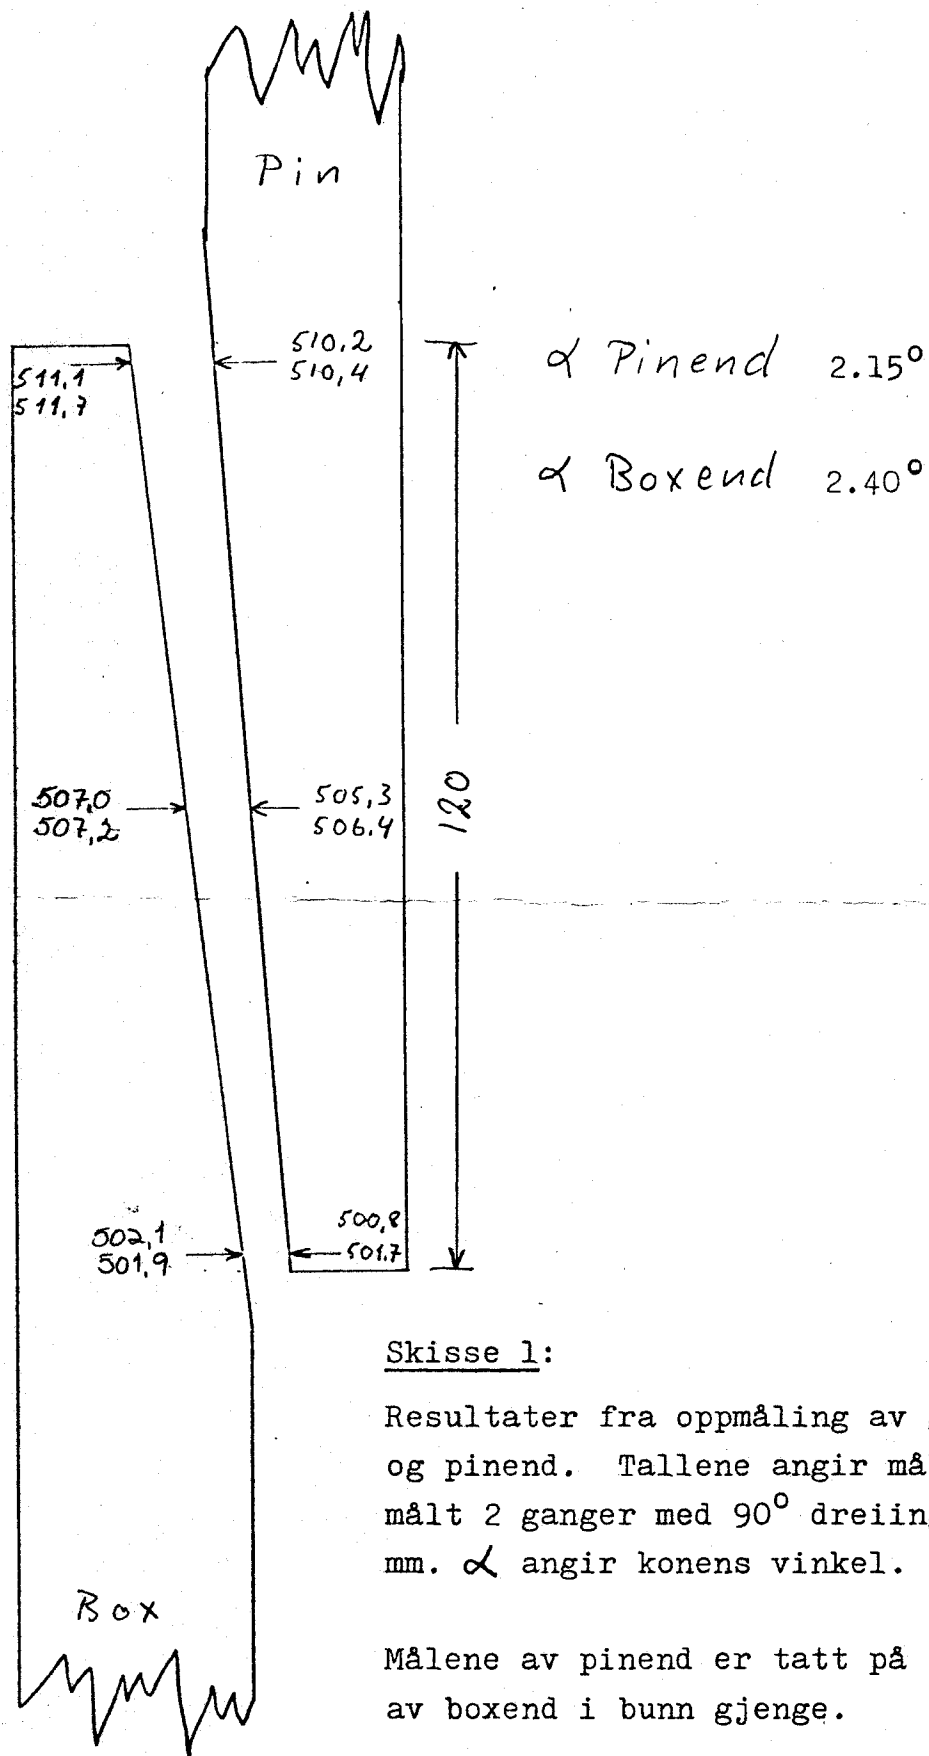
Skisse 1:

The measured angle of the cone on the pin,  $2.15^{\circ}$ , is less than what is accepted by SPI std. 5B, pkt. 3., which gives that the angle shall be between  $2.32^{\circ}$  and  $2.52^{\circ}$ .

1. Oppmålingen ble utført med mikrometer av folk fra vårt maskinverksted. Måleresultatene er vist på skisse 1.
  - Det ble funnet eksentrisitet i pinend på 0.9 mm nederst og 1.1 mm midt på gjengepartiet. P.g.a. stigning på gjengene, vil denne målingen være noe unøyaktig.
  - Åpningsvinkelen på konen til pinend og boxend er identiske. Beregning utfra måleverdiene viser følgende resultat:

$\alpha$  Pinend 2.15°  
 $\alpha$  Boxend 2.40°

Resultater fra oppmåling av gjenger i box- og pinend. Tallene angir målinger av diameter målt 2 ganger med  $90^\circ$  dreining. Alle mål i mm.  $\alpha$  angir konens vinkel. Disse er beregnet.

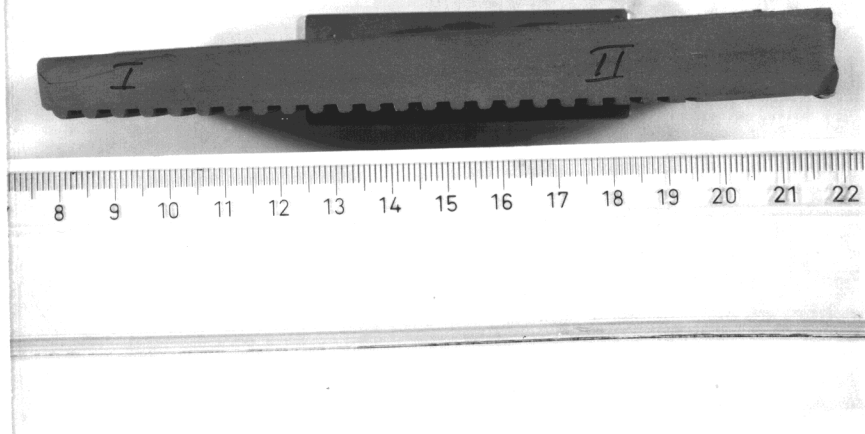
- c) Tannhøydene ble målt til 1.8 mm på pinend, og 2.00 mm på boxend.
2. Bilde 1 viser gjengepartiet fra pinend i snitt. Områdene II og I er vist forstørret i bilde 2, henholdsvis bilde 3. Gjengene i område I viser tildels sterk deformasjon, spesielt i underkant av gjengen. Denne deformasjon er ikke registrert i område II (bilde 2). Her synes gjengene ubeskadiget. Et bilde av gjengenes overflatebeskaffenhet er vist i bilde 4. Det opptrer riper på hver eneste gjenge frem til område II. Her slutter ripene, slik at de siste 5 gjengene er fri for disse skadene.
  3. Mikrofoto (bilde 5) viser tydelig flytelinjer etter deformasjon. Bunnen av gjengene viser ikke denne type skader.
  4. En karbonanalyse av materialet ga følgende resultat:

Bilde 1: Snitt av gjengeparti fra Pin-end, 20" casing.

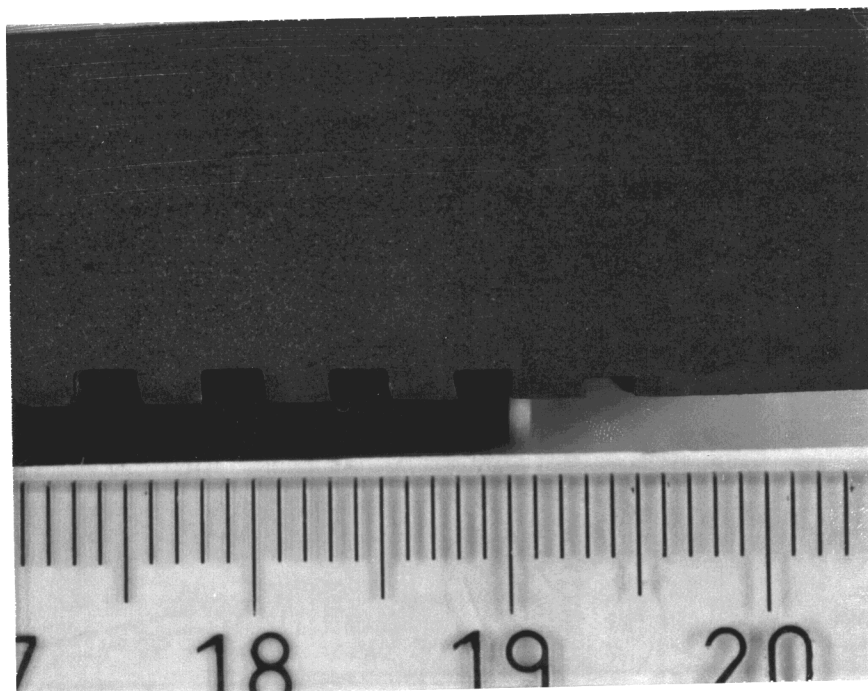
Bilde 2: Snitt av gjengeparti II (bilde 1) uten synlig deformasjon.

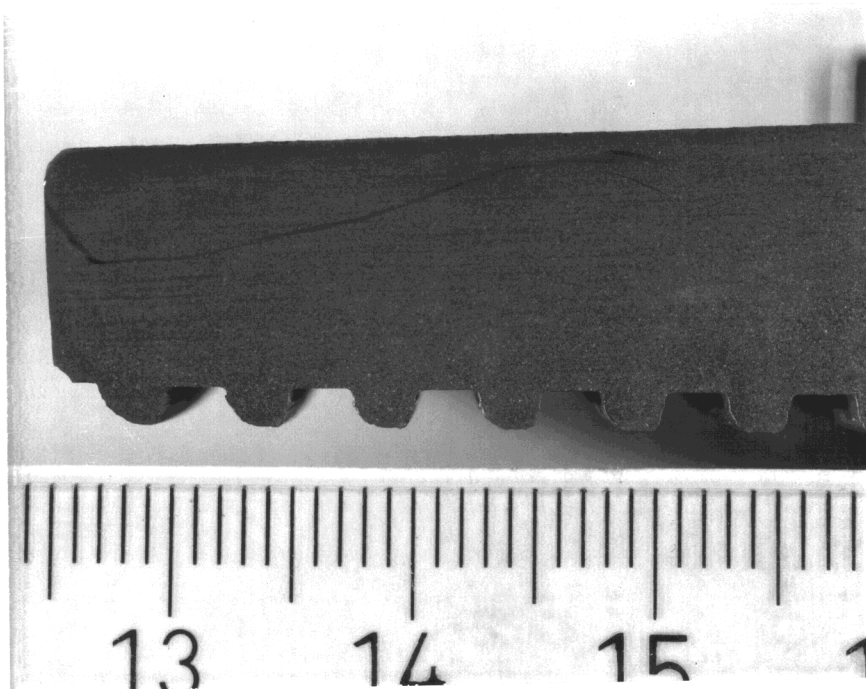
- Differensen i gjengehøyde og det faktum at gjengebunnen ikke var synlig deformert, sammen med de sterke deformasjonene på gjengene, tyder på at disse ikke har vært i ingrep. Dette er den mest sannsynlige grunnen til at gjengeforbindelsen glapp.
- Eksentrisiteten på pinend kan ha vanskeliggjort entringen av gjengene.

Bilde 3: Snitt av gjengeparti I (bilde 1) med synlig deformasjon av gjengene.

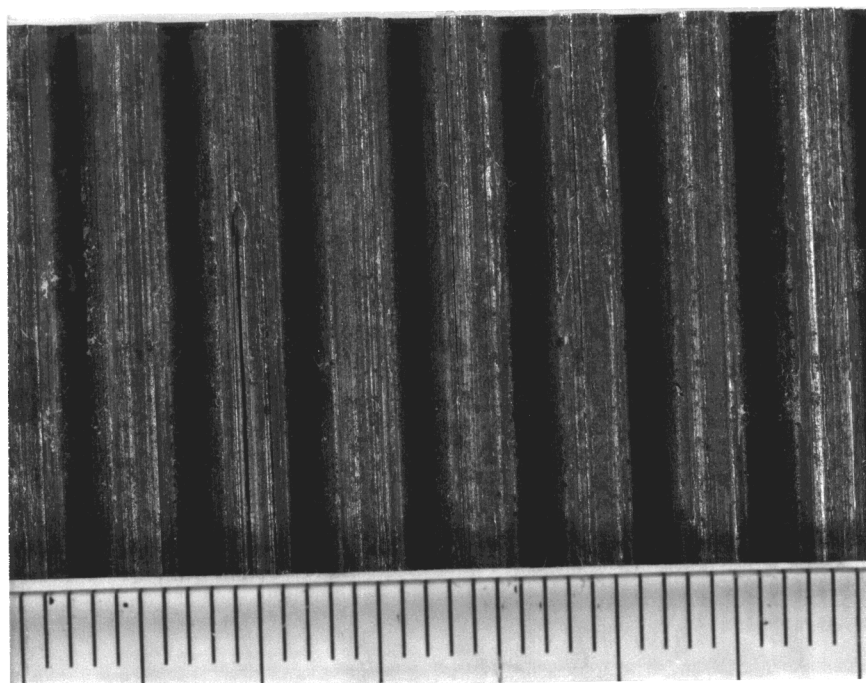
Bilde 4: Gjengeparti I (bilde 1) som viser sterk deformasjon og riper.
