6406/9-1
A/S NORSKE SHELL E & P
END OF WELL REPORT, ONYX SW

Document no: EP200508217992	Type: REPORT	Security:	
Supersedes:	Revision no: Final Copy	Retention code:	
Administered by: J. Simpson	Verified by: R. Woertman	Approved by:	
Date: 29/08/2005	Date:	Date:	
Electr.file loc:			Page: 1
Sort Code: >>>	Doc.type:	Discipline:	EDC:. Hardw:. Area:

6406/9-1 Executive Summary

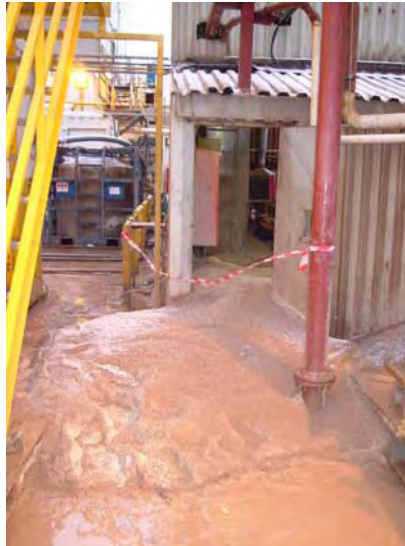
Whilst weighting up the mud to 1.81 s.g. too much air pressure was used to clear a blocked vent line on one of the barite hoppers, caused by the surge tank having been loaded with more than 30 MT barite, whereby some of the barite started filling the vent line. As the valve end of the aft end of this surge tank does not hold pressure sufficiently, the increased air pressure caused the discharge of barite onto the decks. Whilst troubleshooting the failure – it turned out the valve was installed upside down – further barite was allowed to escape. A total of approx. 14 MT barite was spilt from the tank. The valve was repaired without implications to the drilling progress and

the area cleaned up. The majority of the barite was transferred to pit 5, whilst the remainder was cleaned up by Swaco. A picture of the situation is shown below.

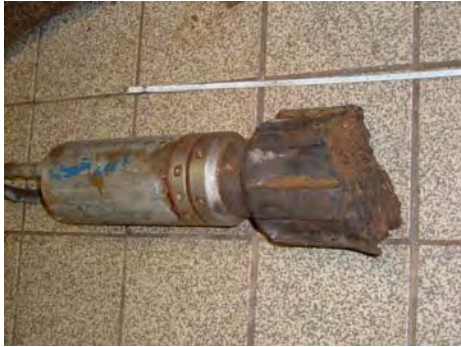
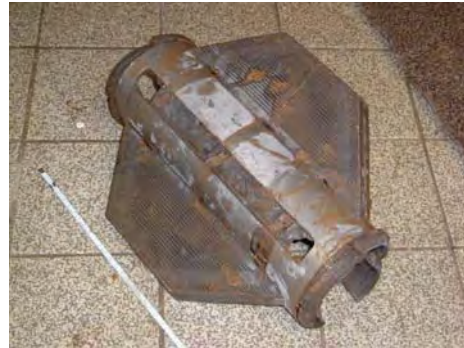
The calliper log showed an average hole size across the cement interval of 12.346", with minor washouts observed at the sand interval (max OD 13"). TOC outside the 13 3/8" casing was recorded as 2,510m. The difference between drilling and wireline depths was approx. 2m. The second wireline run proceeded without major incidents. A 5,000 lbs overpull was observed at 4,050m, potentially due to a ledge in the sand stringer interval (potentially where fin was lost). Trip tank levels were stable throughout the logging programme.

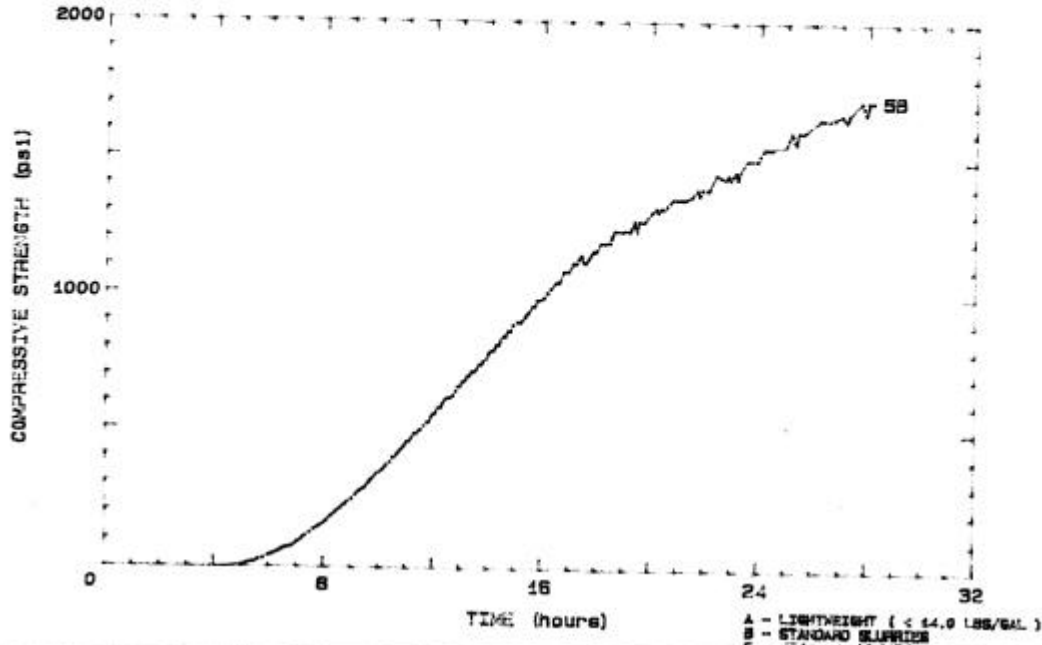
ULTRASONIC CEMENT ANALYZER
 HALLIBURTON SERVICES

INITIAL SET: 50 @ 5:06
 STRENGTH 1: 500 @ 11:30
 STRENGTH 2: 19999
 CURR. STR.: 1716 @ 28:15

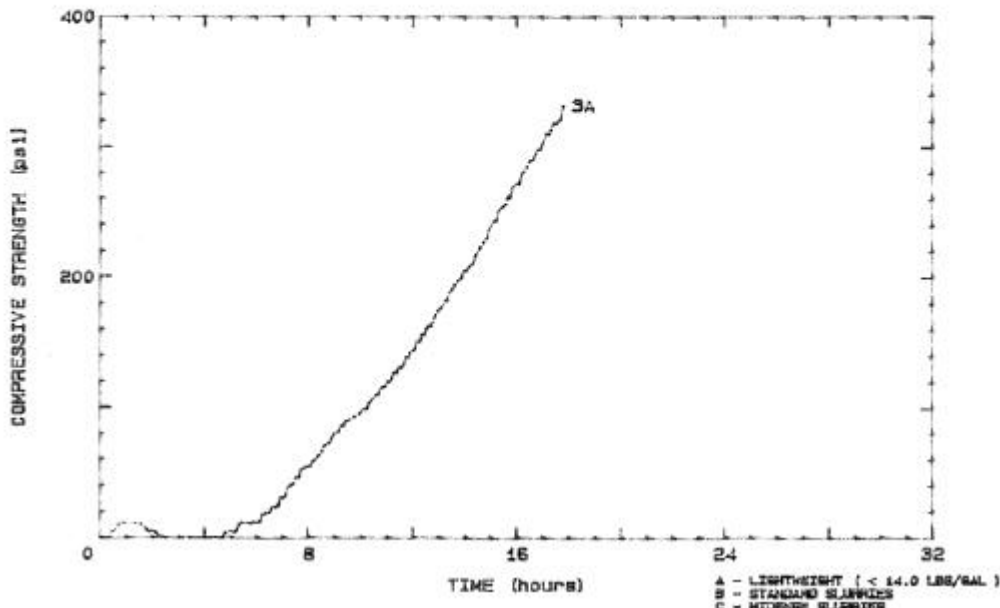
PROJECT NO.: N5041-Z-426
 DATE: 12/16/09
 PRESSURE: 3000 psi
 TEMPERATURE: 68 F
 CEMENT: Norcem G + BZ-F10 + 0.6 blk HR-4L + 3.20 blk Cenolite liquid + 0.6 blk NF6 + Sea water

ULTRASONIC CEMENT ANALYZER
 HALLIBURTON SERVICES

INITIAL SET: 50 @ 7:43
 STRENGTH 1: 500
 STRENGTH 2: 19999
 CURR. STR.: 332 @ 17:51

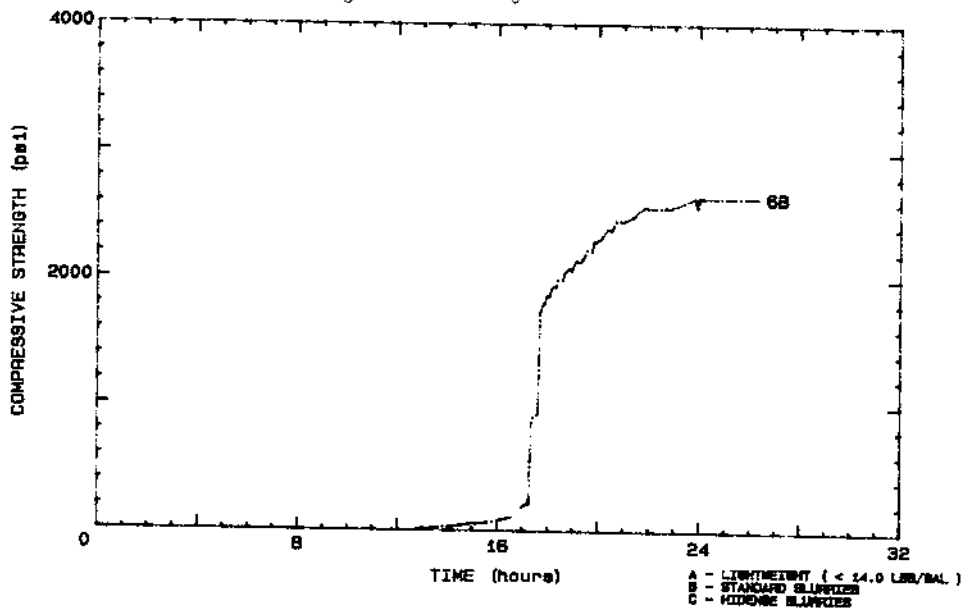
INITIAL SET: 50 @ 14:35
 STRENGTH 1 : 500 @ 17:16
 STRENGTH 2 : 19999
 CURR. STR. : 2642 @ 26:22

CEMENT: Maxcem + 35% SSAI + 30% Bore microprax + 0.10 l/ub NF-6 + 12 l/ub SCR-500L + 16 l/ub Zoneseal + 8 l/ub tuned Y13L + 0.20 Bore SA-541

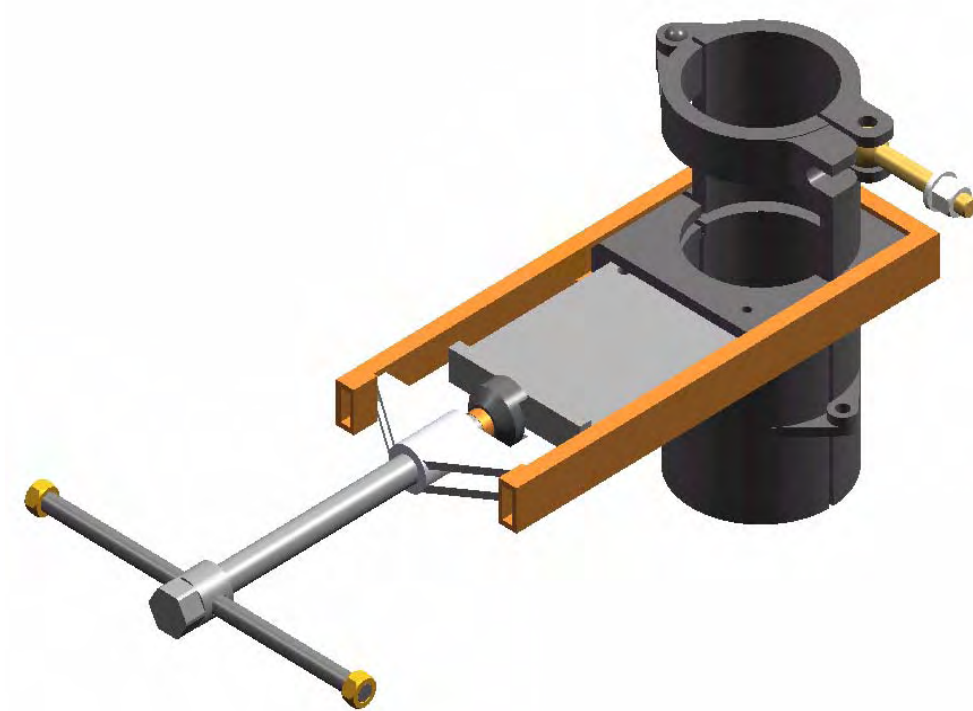
Core Laydown.

A laydown cradle was raised to the drill floor, to allow the core to be latched to it as soon as possible, minimising the time for any potential damage. This cradle was then removed from the drill floor through the v doors and down onto the main deck for processing.

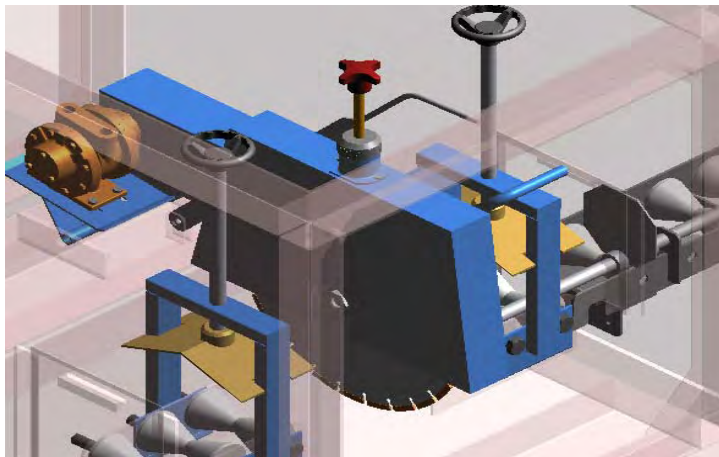
The core is divided into 1 metre sections. As processing is a non-routine rig activity all essential personnel were kept to a minimum and additional PPE of goggles, dusk mask and ear protection worn

Where the core was marked the liner was, cut and dispensed to the layout area for processing.
