ESSO EXPLORATION AND PRODUCTION NORWAY, INC.

WELL 15/8-1

FINAL WELL REPORT

A1-2126

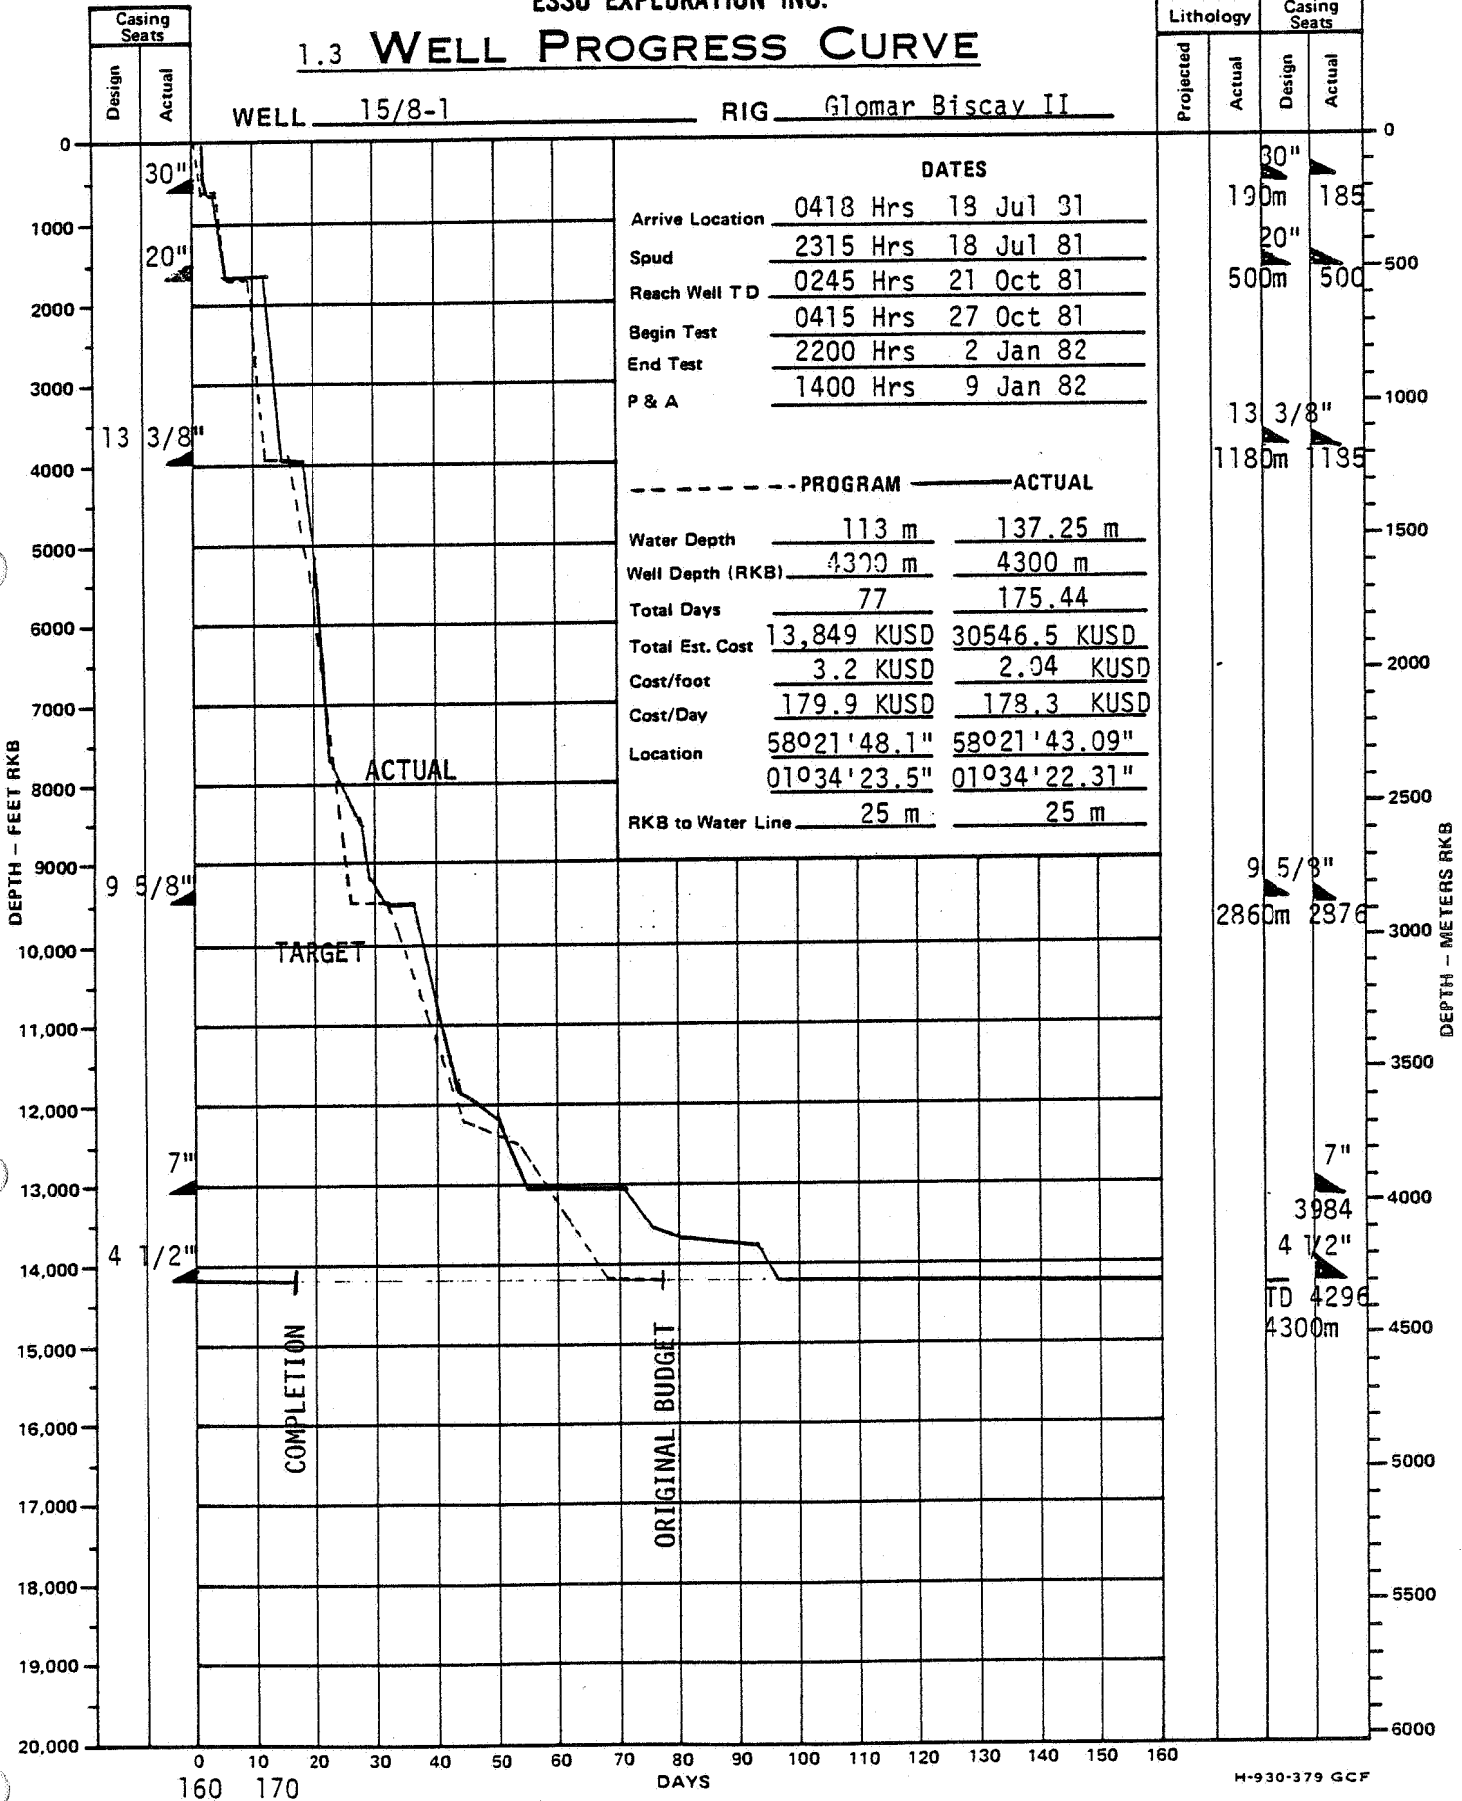
1.3 WELL PROGRESS CURVE

WELL 15/8-1 RIG Glomar Biscay II

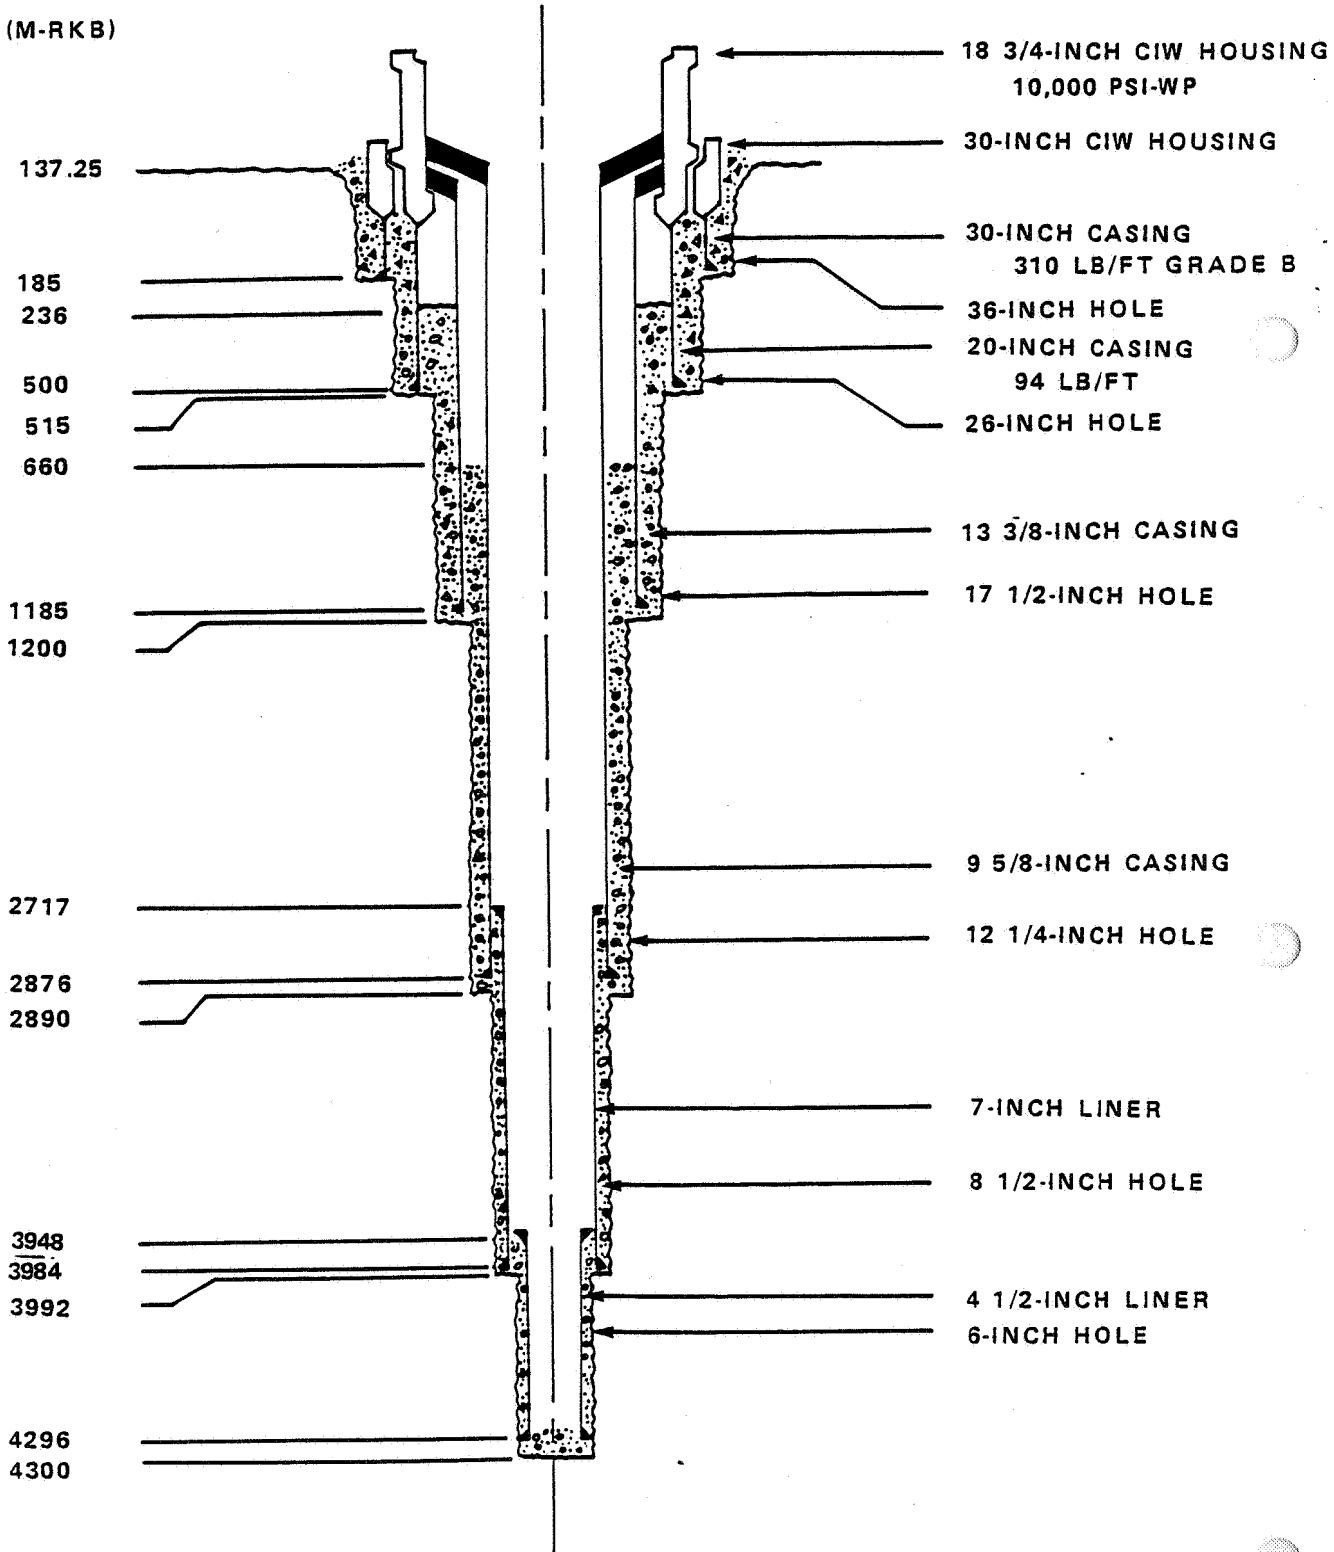
1.4 WELLBORE SCHEMATIC

WELL 15/8-1

DEPTH (M-RKB)

The Glomar Biscay II arrived at the 15/8-1 location at 0418 hours, 18 July 1981. The well consisted of 30" casing in a 36" hole, 20" casing in a 26" hole, 13-3/8" in a 17-1/2" hole, 9-5/8" casing in a 12-1/4" hole, 7" liner in an 8-1/2" hole and a 4-1/2" liner in a 6" hole. After reaching TD, logging the lower portion of the hole, and setting the 4-1/2" liner, the 7" liner was tied back to the surface with a 7" casing string. Four zones were production tested. The well was abandoned as shown in the abandonment profile.

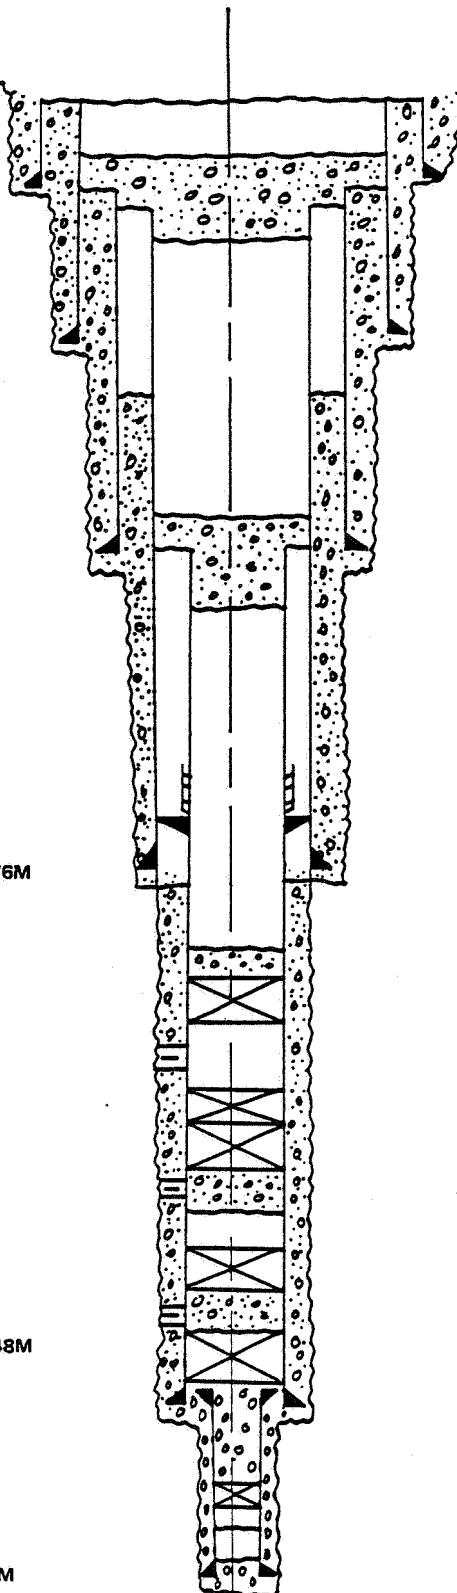
**WELL 15/8-1
1.5 ABANDONMENT PROFILE**

DEPTHS IN M-RKB

SEA FLOOR 137M RKB

30" CASING SHOE
AT 185M

TOP OF CEMENT IN
13 3/8" x 20" ANNULUS
236M (FROM
TEMPERATURE SURVEY)
20" CASING SHOE
AT 500M

TOP OF CEMENT IN
9 5/8" x 13 3/8" ANNULUS
660M (FROM
TEMPERATURE SURVEY)
13 3/8" CASING SHOE
AT 1185M

TOP OF 7" LINER AT 2717M

9 5/8" CASING SHOE AT 2876M

PERFORATIONS 3643-3653M

PERFORATIONS 3688-3697M

BRIDGE PLUG AT 3946M

PACKER AT 4070M
SQUEEZE NO.1

An attempt was made to recover the 7" tie-back string. The string would not pull free at the tie-back sleeve. Therefore, the 7" casing was cut at 1182 m, and after ensuring that the well was not flowing, the 7" casing was recovered with a spear. A plug was set from 1212 m to 1092 m with 125 sxs of cement. The plug was tagged at 1104 m and successfully tested to 2000 psi. The 9-5/8" casing was cut at 238.5 m and recovered with a spear. Eighty-five kips of overpull were required. The 9-5/8" x 13-3/8" annulus was tested to 1200 psi - 18.1 EMW - 2 ppg above leak-off at the 13-3/8" shoe. The 13-3/8" casing was cut at 203 m and recovered with a modified spear assembly that utilized a 3.5 m pup joint in between the spear and stop ring. The 13-3/8" x 20" annulus was tested to 500 psi - 18.1 EMW - 3.8 ppg above leak-off at the 20" shoe. A balanced plug was set from 365 m to 165 m with 435 sxs cement. The riser and BOP stack were pulled after the yellow and blue control pod

lines were unfrozen with steam. While pulling the stack, it was discovered that the #1 and #4 guide line to the PGB were disconnected. The Mantis submarine was put in the water and re-established guide line #4. The 20" and 30" casing strings were cut at 142 m, 5.2 m below the mud line. The 20", 30" and PGB were retrieved. The rig was deballasted, but due to weather delays, the last anchor was not picked up until 1400 hours, January 9, 1982, at which time the rig was released to drill well 16/7-2.
