FINAL WELL REPORT
Drilling and Completion
Licence no: PL050 7 PL120 ,
Well: NO 34/10-48 S, NO 34/10-48 A,
NO 34/10-48 A T2

Subjects: EXPLORATION WELL, Drilling and Completion

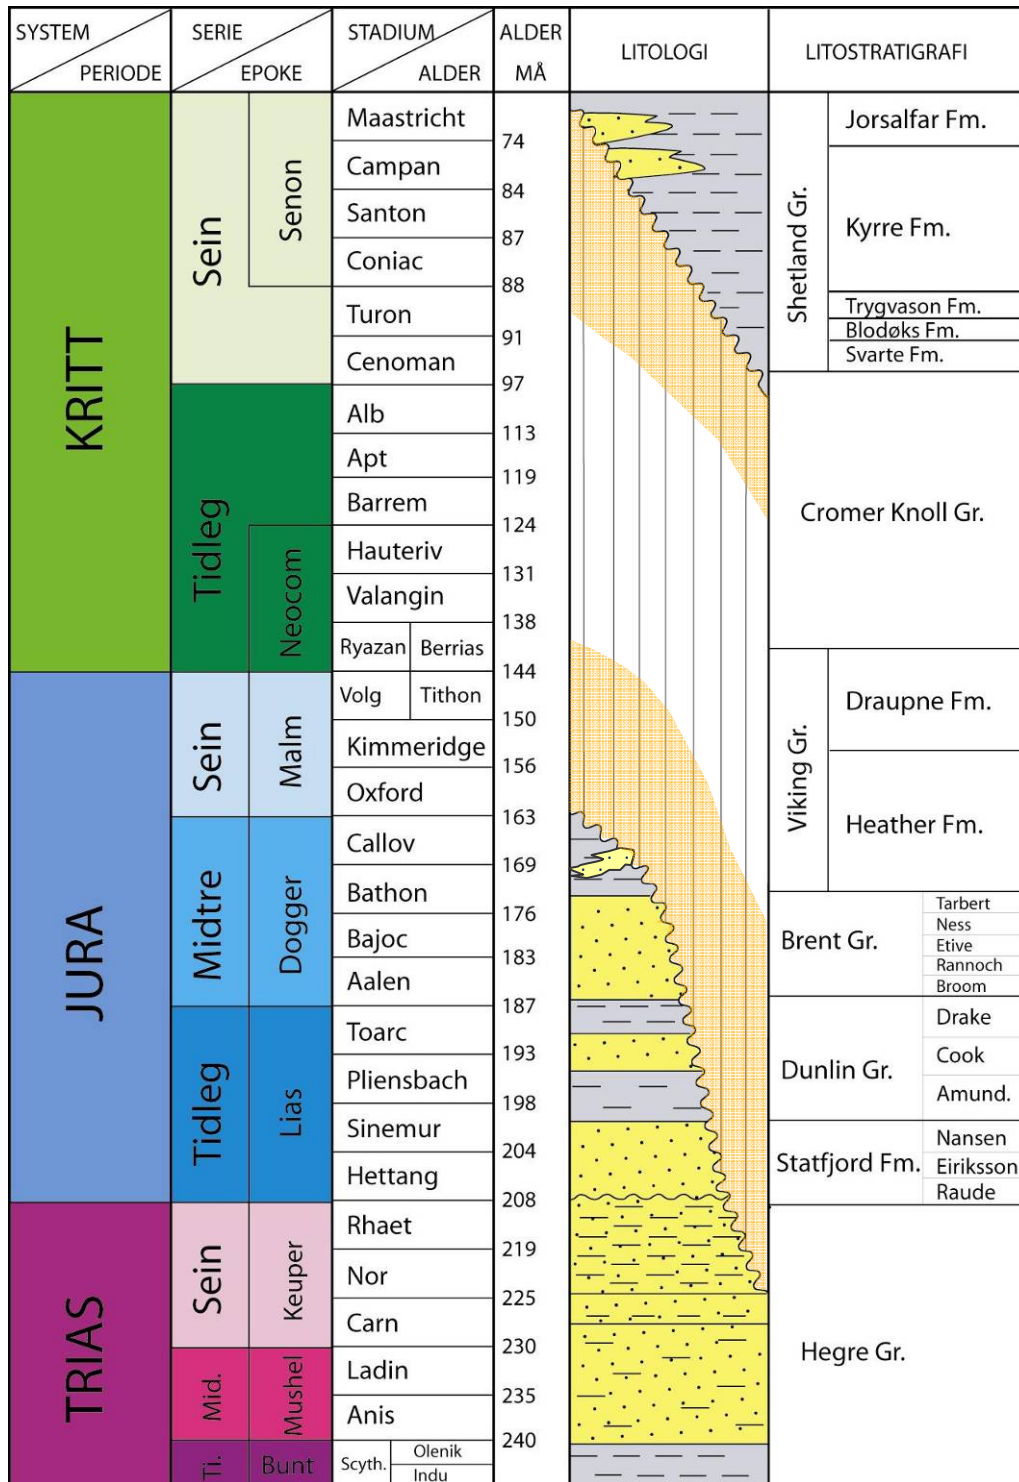
Figure 4.1.2: A generalized stratigraphy for the Gullfaks and Topas area. Note the light orange colour which indicates potential sediment accumulation in the Topas area.

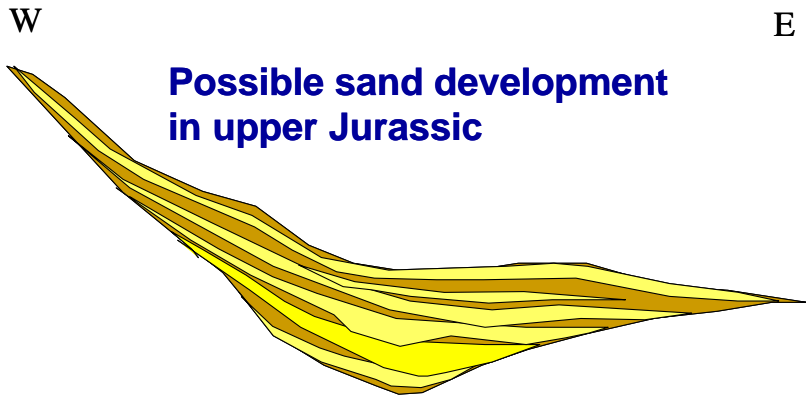
Figure 4.1.3, generalised development of sand deposits in late Jurassic/Heater Formation in Topas area

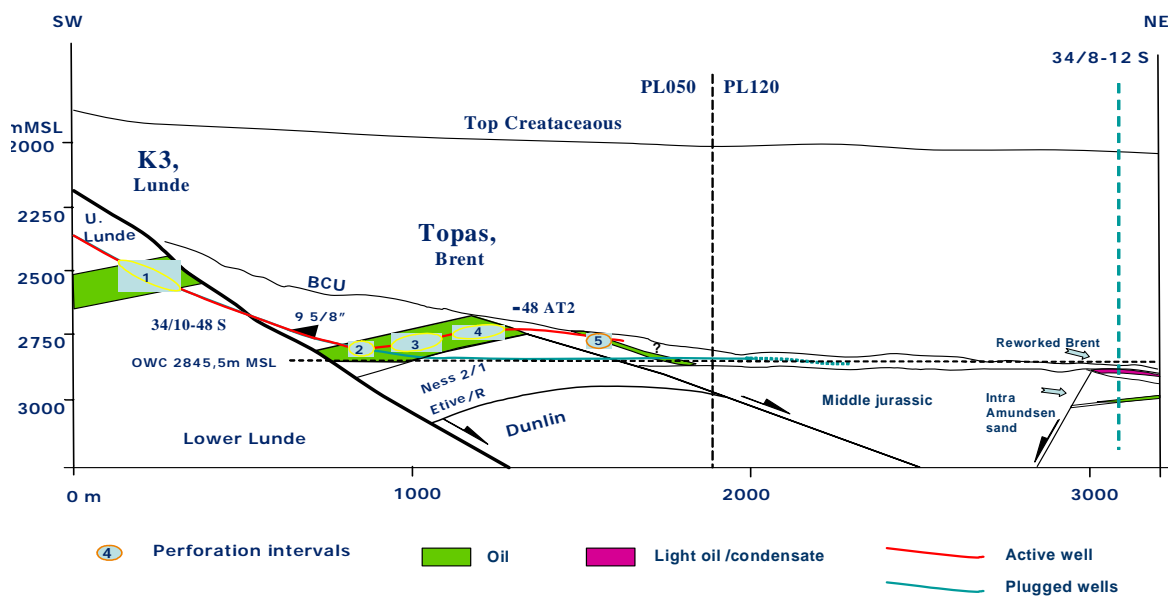
Discoveries in the Topas area
 Exploration wells 34/10-48 S and 34/8-12 S

Figure 4.1.5: Discoveries in the Topas area.

Another sidetrack, this time an open hole Brent sidetrack, was performed at 5600m MD at the end of the reservoir unit in the southern area of Topas. The drilling was slow and went to a final stop as penetration of less than 1m pr hour was achieved. The last 50m of well 34/10-48AT2 drilled once more through intra Heather sandstones with apparently good reservoir quality and hydrocarbon saturation, figure 4.1.5.

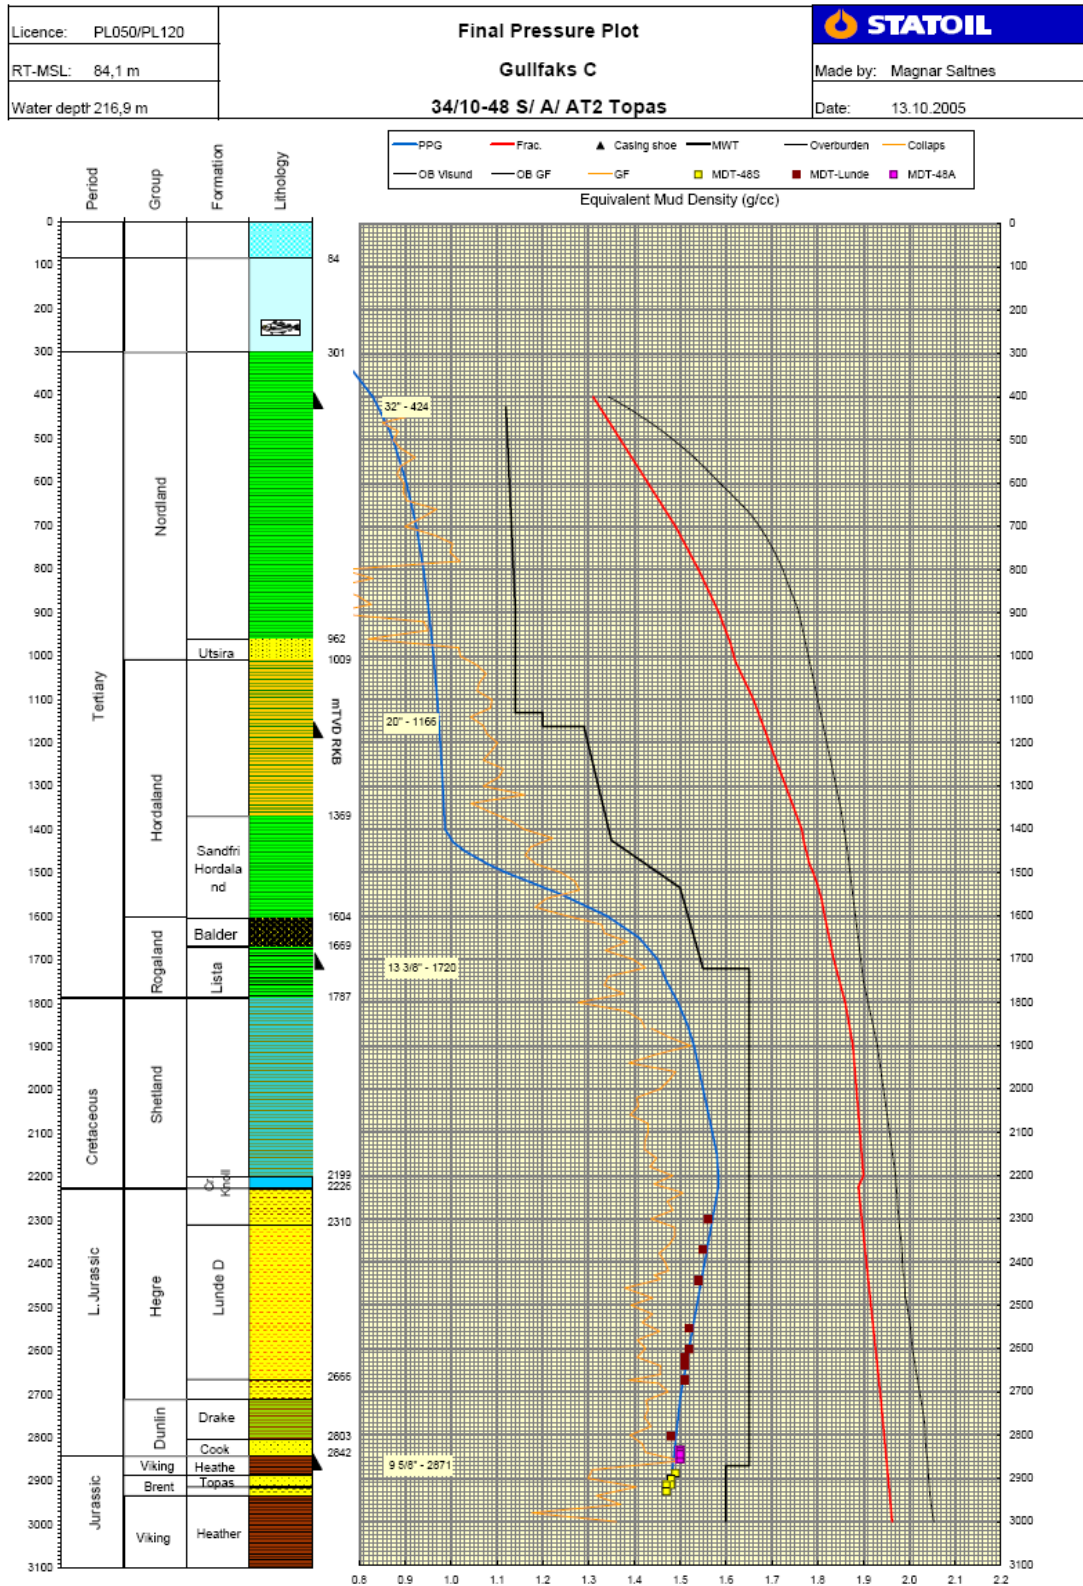
4.10 Formation pressure plot, true vertical depth

Hydrostatic gradient to surface: 1,63 g/cm3 while circulating at 1200 lpm. (i.e. dynamic reading, MW = 1,57 sg)															
Minimum/ Maximum measured pore pressure (ref RKB): 1,50 g/cm ³															
Formation pressure test Quality in OW "PRES_QUAL" 0:Lost Seal, 1:Tight, 2:Poor (<10 mD/cP), 3:Good (10-100 mD/cP), 4:Very Good (>100 mD/cP)
